The July 29, 1998, debris flow and landslide dam at Capricorn Creek, Mount Meager Volcanic Complex, southern Coast Mountains, British Columbia

Michael J. Bovis and Matthias Jakob

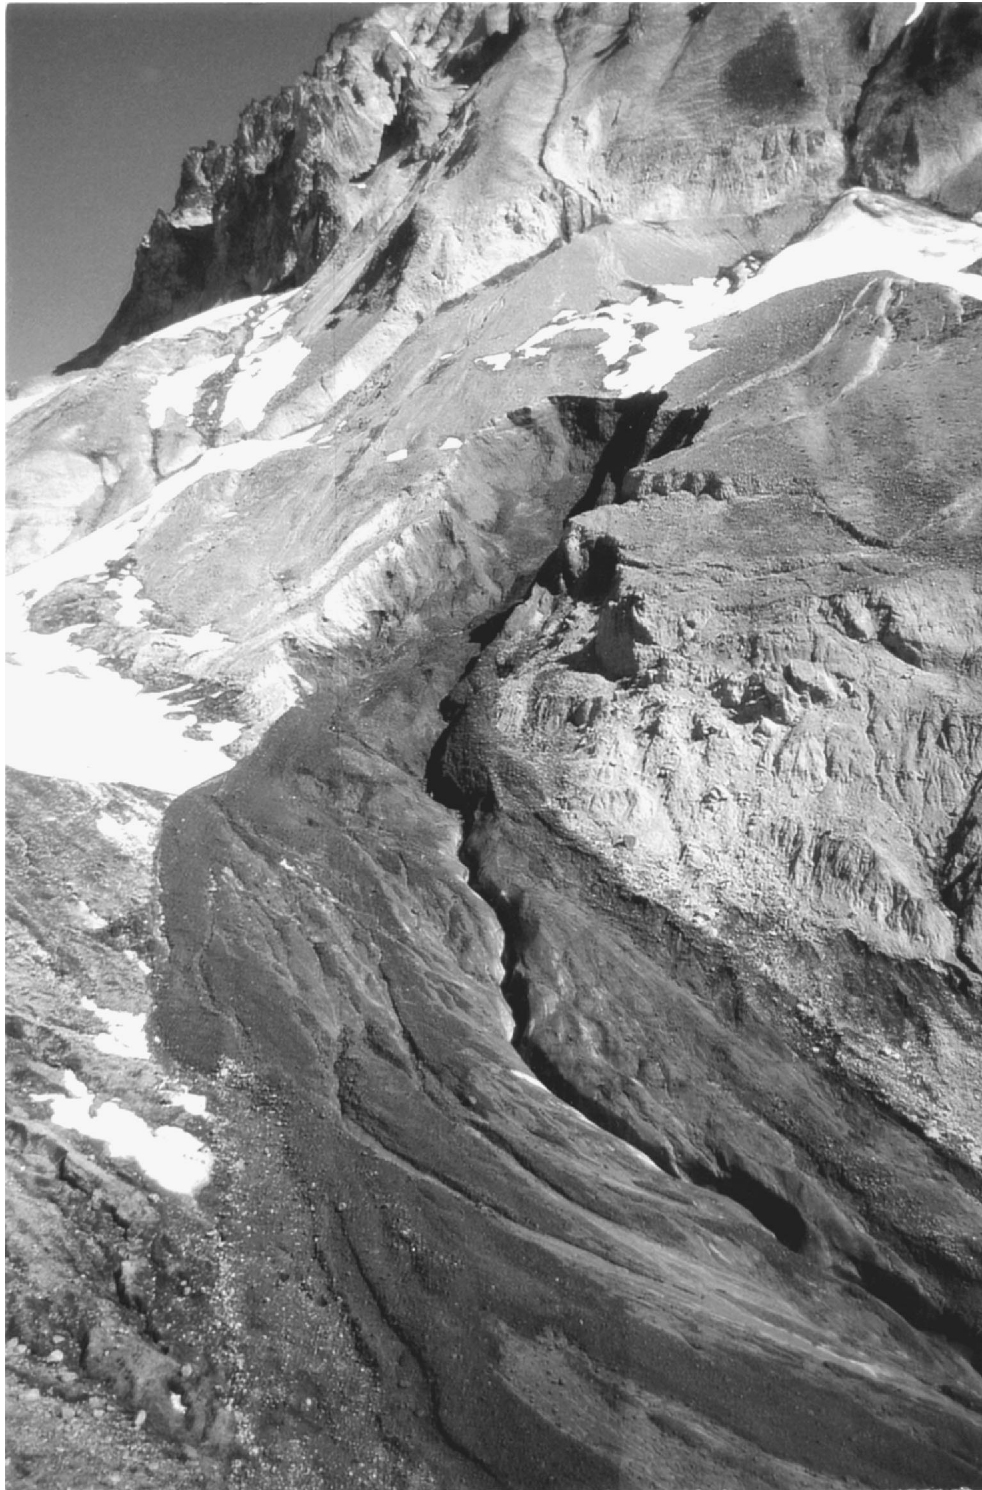
Fig. 3. Detachment zone of the 1998 debris flow on the south flank of Mount Meager. Note tension cracks and sacking features on the right side of detachment zone. Debris-covered Capricorn Glacier is in the foreground. The failure scarp is approximately 80 m across at its widest point. Photo taken August 2, 1998.

On July 29, 1998, a $550\,000 \text{ m}^3$ debris slide released from upper Capricorn Creek basin in the Mount Meager Volcanic Complex (Figs. 1, 2), triggering a debris flow which ran 6 km down Capricorn Creek. The debris slide that triggered the debris flow originated from a thick blanket of poorly consolidated colluvium on the south flank of the Mount Meager stratovolcano (Fig. 3). The slide was initiated by ac-

The 1998 debris flow was triggered by a debris slide detachment of approximately $5.5 \times 10^5 \text{ m}^3$ of colluvium from a $30\text{--}35^\circ$ slope on the southwest flank of Mount Meager (Figs. 3, 7). The debris slide fell 200 m to the debris-covered surface of Capricorn Glacier, where large amounts of supraglacial debris, and probably water, were entrained. It is likely that the mass was fully developed as a debris flow within upper Capricorn Creek. The volume of the initial debris slide (length 240 m, depth 30 m, width 70 m) was determined by a hand-held laser rangefinder survey of the detachment zone. Ground inspection of the detachment zone

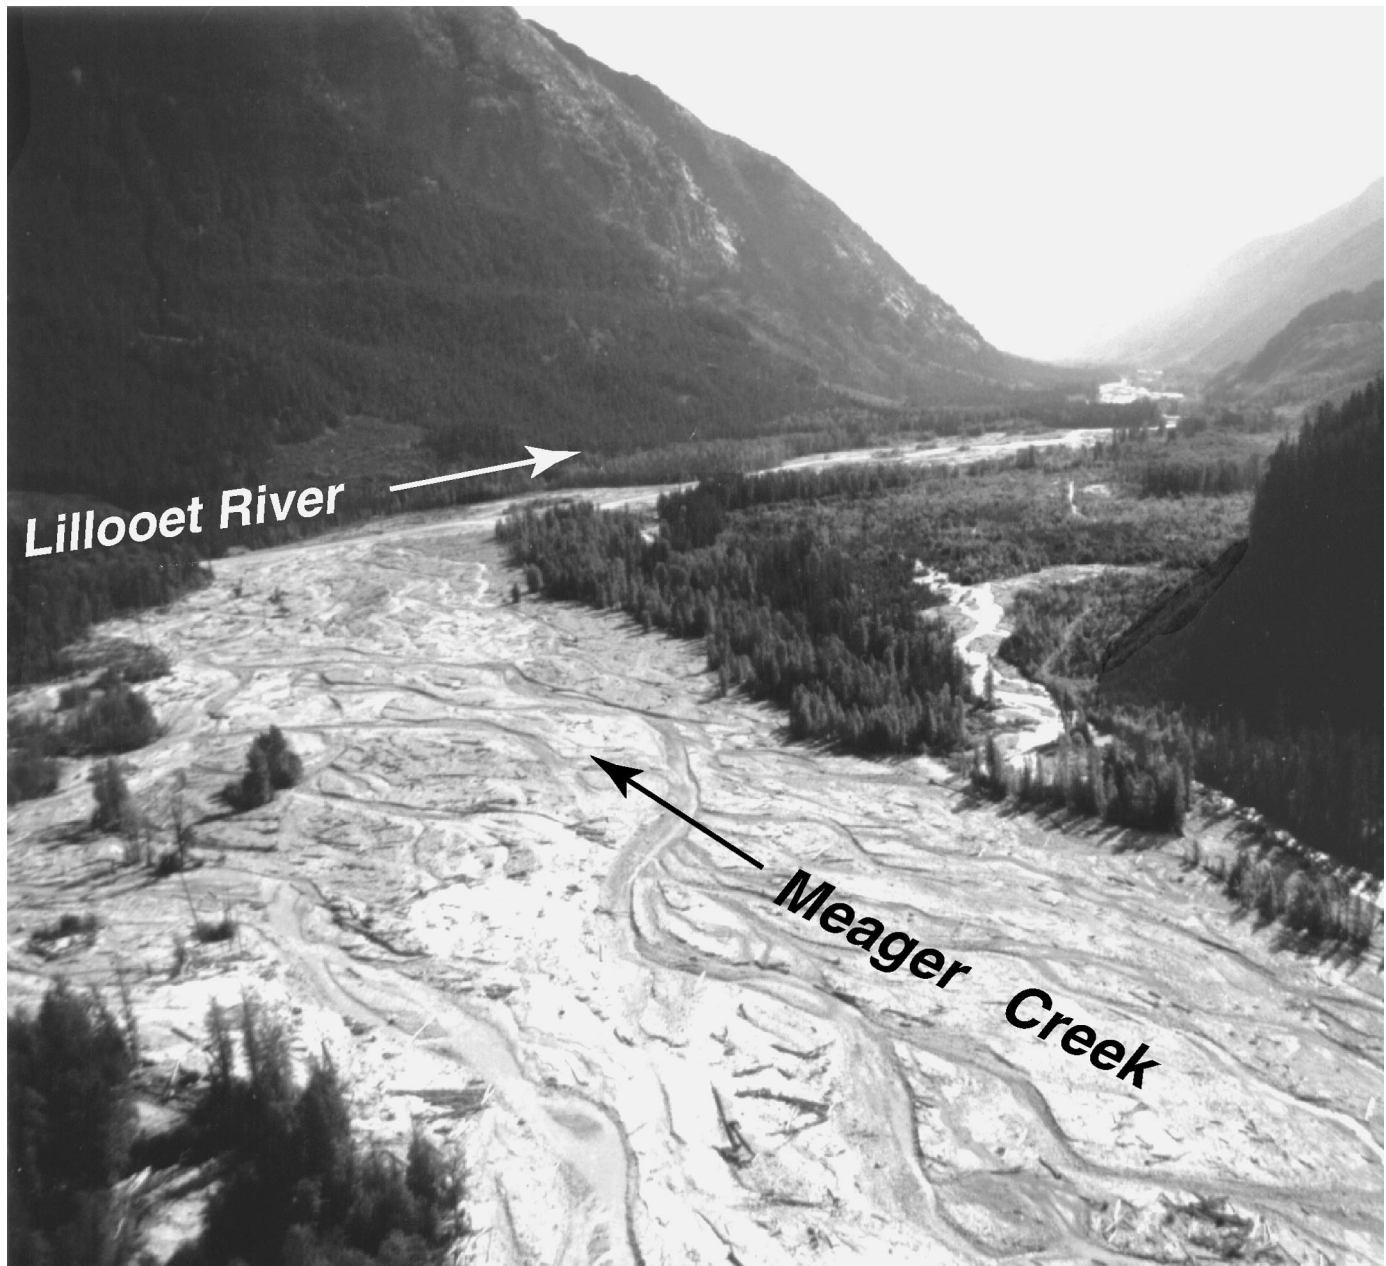
Fig. 5. Lower Meager Creek flood plain downstream of Capricorn Creek, showing extensive recent aggradation from hyperconcentrated flows and fluvial reworking of the July 1998 debris flow deposits. Lillooet River is at the foot of the steep slope in the background. Photo taken August 2, 1998.

The high frequency of catastrophic mass movements within Capricorn Creek and other basins tributary to Meager Creek causes the latter to have a disproportionately high sediment load relative to its drainage area and discharge (Jordan 1987; Jordan and Slaymaker 1991). It is a dominant coarse-sediment source for Lillooet River, which abruptly changes its morphology from a single-thread, meandering channel to a broad, braided system at the Meager Creek confluence. The 1998 debris flow at Capricorn Creek caused notable further aggradation along the lower Meager Creek flood plain (Fig. 5).

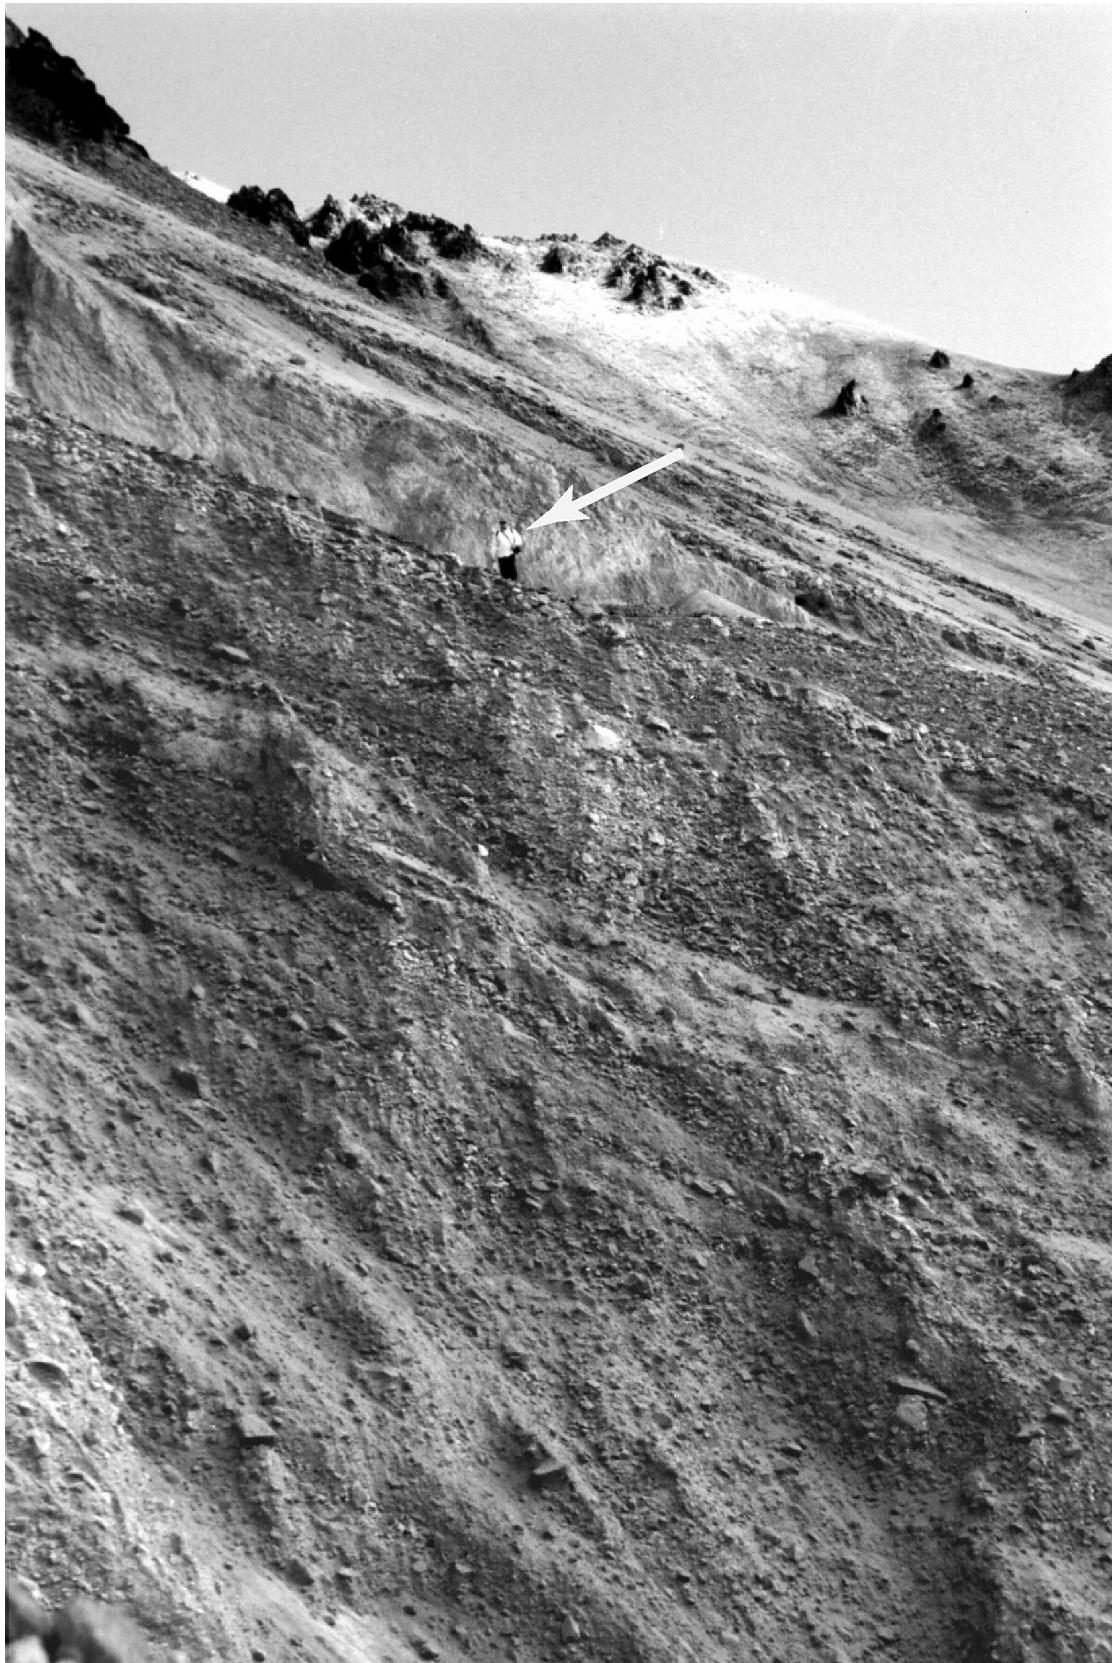
Fig. 8. Section through stratified colluvium on the east flank of the 1998 landslide detachment zone. Person standing (indicated by arrow) gives scale. Photo taken August 2, 1998.

walls revealed a crudely stratified deposit with a clast-supported, talus-like structure, consisting of rubble layers with relatively few fines sandwiched between blocky diamicton layers with matrix-supported structure (Fig. 8). The surface layer was a loose talus deposit, comprising volcanic clasts (porphyritic felsic to intermediate lavas and felsic tuffs) derived from the weathering of Mount Meager. This stratigraphy suggests a composite colluvial blanket composed of rockfall material, interspersed with debris flow diamictons.
